Contract #: 04-0120F4Cty: SF/ALA Rte: 80 PM: 13.2/13.9File #: 1.28**WELDING INSPECTION REPORT****Resident Engineer:** Casey, William**Address:** 333 Burma Road**City:** Oakland, CA 94607**Report No:** WIR-029755**Date Inspected:** 27-Jun-2013**Project Name:** SAS Superstructure**OSM Arrival Time:** 700**Prime Contractor:** American Bridge/Fluor Enterprises, a JV**OSM Departure Time:** 1730**Contractor:** American Bridge/Fluor Enterprises, a JV**Location:** Job Site**CWI Name:** Bernie Docena**CWI Present:** Yes No**Inspected CWI report:** Yes No N/A**Rod Oven in Use:** Yes No N/A**Electrode to specification:** Yes No N/A**Weld Procedures Followed:** Yes No N/A**Qualified Welders:** Yes No N/A**Verified Joint Fit-up:** Yes No N/A**Approved Drawings:** Yes No N/A**Approved WPS:** Yes No N/A**Delayed / Cancelled:** Yes No N/A**Bridge No:** 34-0006**Component:** SAS Tower**Summary of Items Observed:**

Tower Electroslag Welds:

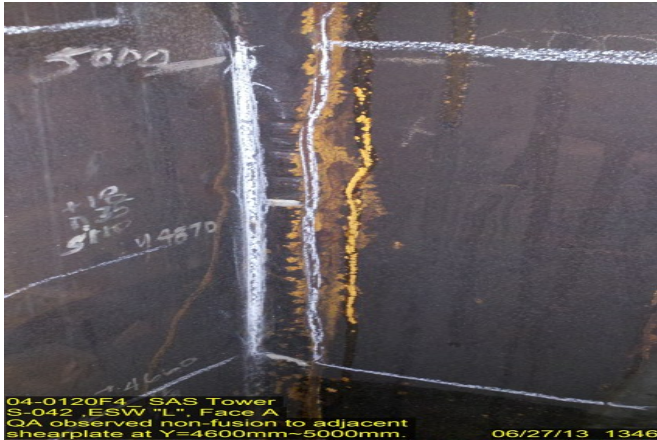
ESW pitch & catch UT was performed per ABF Sup. Procedure 3 UT of ESW Groove Welds Pitch- Catch. The tandem UT report for work performed on this date will be completed once QC Inspector Jesse Cayabyab has also inspected the locations and information is in agreement with QA. Final UT report will be signed by both QA/QC parties to be presented to ABF & CT METS for further review.
